Pentium® II Xeon™ Processor Specification Update

Release Date: February 2000

Order Number: 243776-020

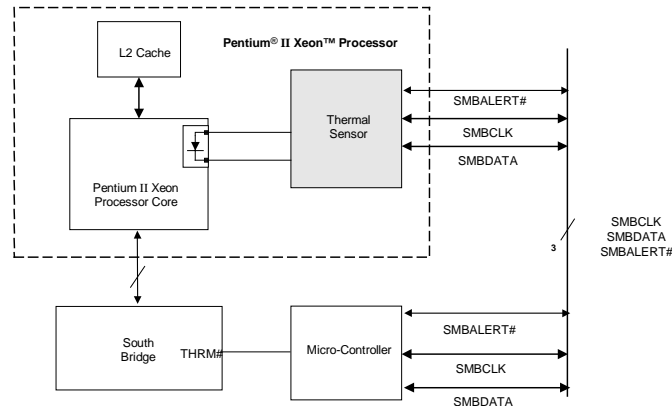
Figure 1. An Example of Microcontroller Driven Thermal Management

D30. Thermal Sensor May Assert SMBALERT# Incorrectly

Problem: The Pentium II Xeon processor has a thermal sensor that monitors the processor core's temperature. The thermal sensor asserts SMBALERT# if the processor temperature exceeds the temperature limits set in the Alarm Threshold Registers (T_{HIGH} , T_{LOW}). It also sets the corresponding Status Register bits to identify the cause of the interrupt. Figure 1 gives one example of the how the SMBALERT# signal could be used in a system.

Under the conditions described below, the thermal sensor incorrectly generates the SMBALERT# interrupt. All of the following conditions must be met to trigger a false interrupt:

Workaround: Three different (mutually exclusive) workarounds are possible:

1. Before servicing an interrupt from the thermal sensor, read and compare the processor thermal reading with the threshold limits (T_{HIGH} or T_{LOW}). Figures 2 and 3 provide basic flowcharts for the implementation of this workaround in an interrupt driven system.
2. If the firmware implemented polls the Status Register only, then before taking any action, re-read the temperature register and do a comparison with the alarm threshold limits (T_{HIGH} or T_{LOW}) to determine if the value is actually still within the temperature window.
3. Use a temperature polling scheme to monitor the processor temperature
